## 4.02 GEOMETRIC DEFICIENCIES

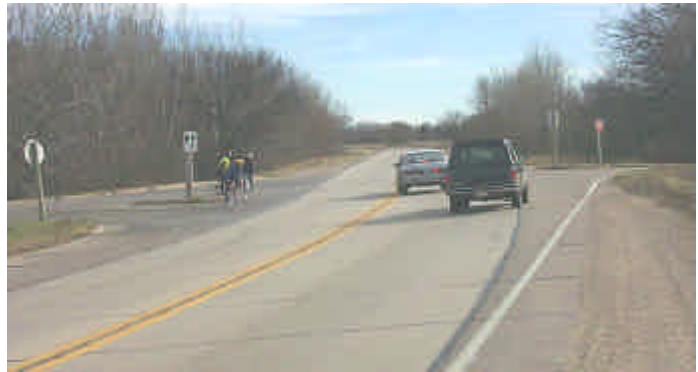
**Figure 4.02-2 No Left or Right Turn Lanes  
Intersection of Lake Kegonsa  
Road and USH 51**

At many rural intersections, USH 51 has no designated turning lanes. Figure 4.02-2 shows an example of this geometry. At Lake Kegonsa Road, USH 51 through vehicles share a single lane with left and right turning vehicles. USH 51 has an exclusive left turn lane at only one rural intersection: CTH A just west of IH 39/90.

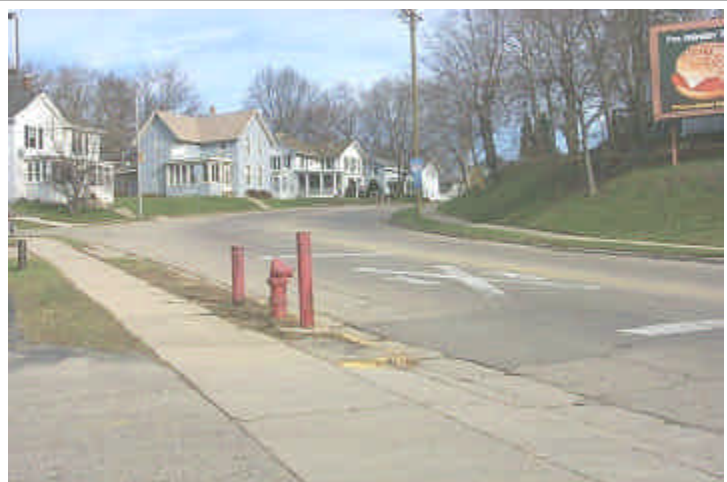
**Figure 4.02-1 Horizontal/Vertical Curve East of  
Stoughton Railroad Crossing**

Curve data was not available for three roadway segments: IH 39/90 to CTH W, CTH N to Page Street, and STH 138 (west) to Jackson Street/Hults Road. The horizontal and vertical curves on these segments could not be evaluated for adequacy. Visual inspection suggests that the horizontal and vertical curves near the railroad crossing in Stoughton may be substandard (see Figure 4.02-1).
